SUMMER FLOOD OF 1973

DEPARTMENT OF THE ARMY
CORPS OF ENGINEERS
NEW ENGLAND DIVISION

MARCH 1974

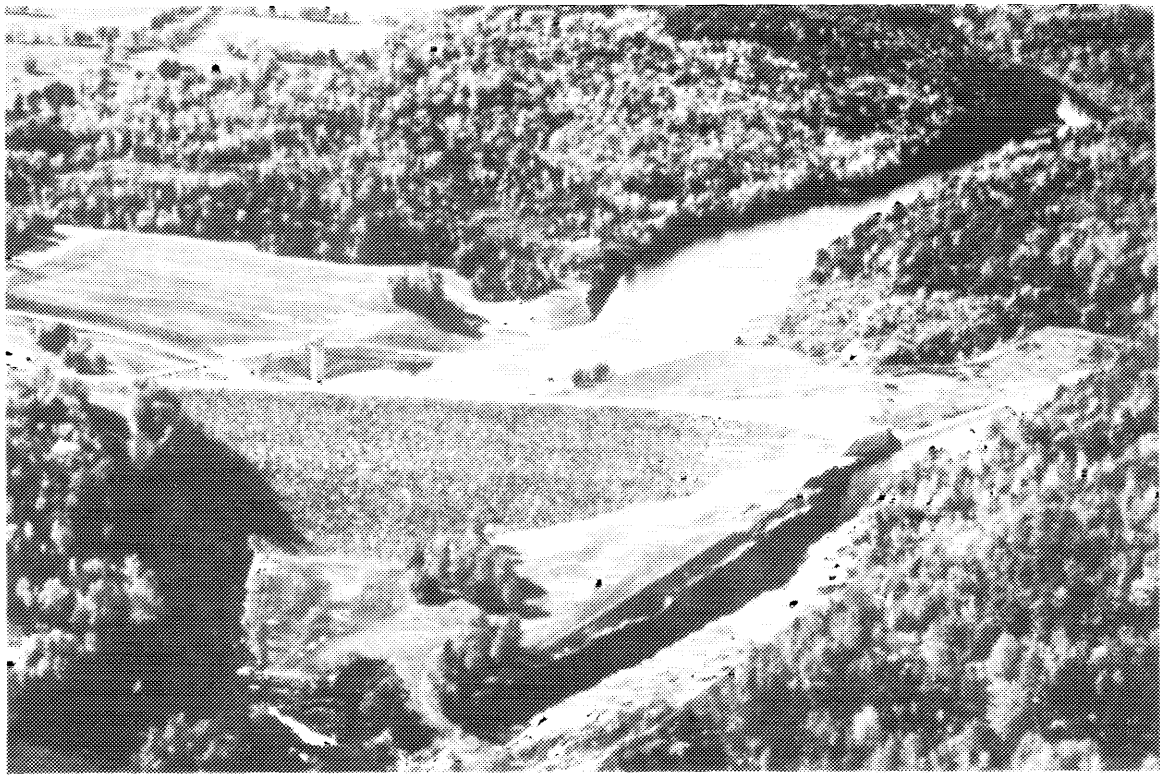
North Hartland Reservoir, Connecticut River Basin.
Permanent pool (before)

and 50% full (after)

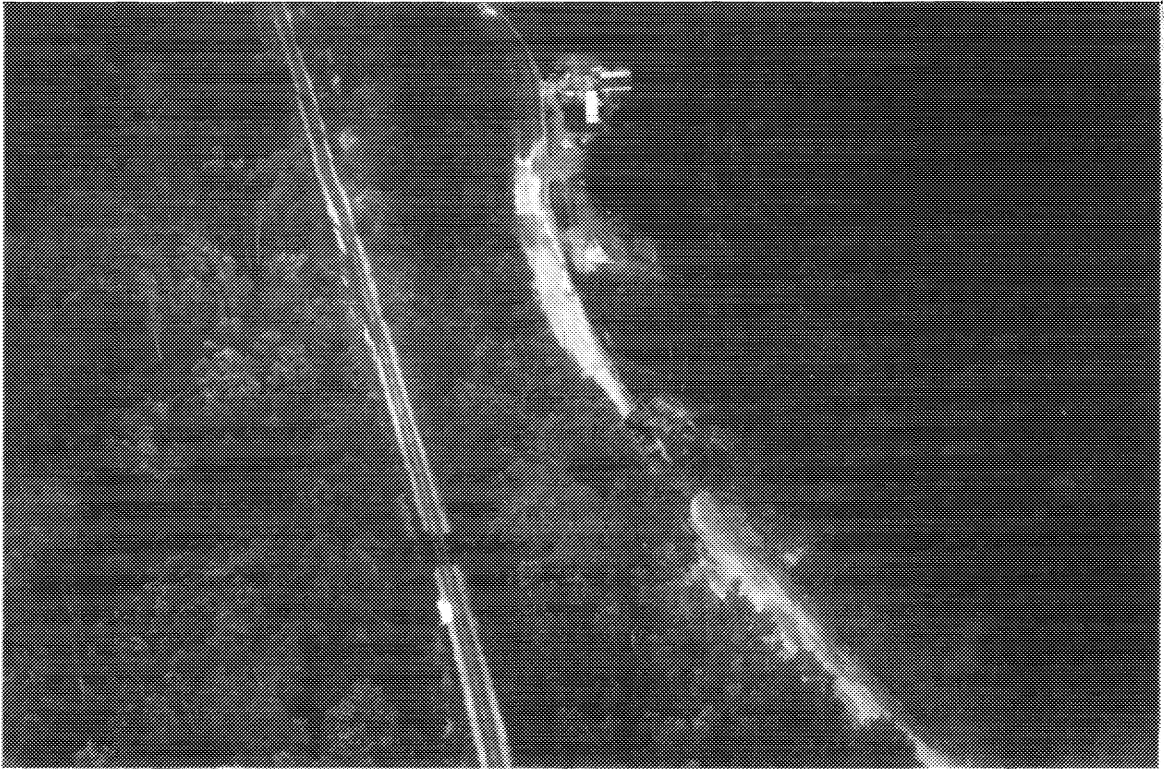
Bridge and Railroad Beds became victims of surging water.

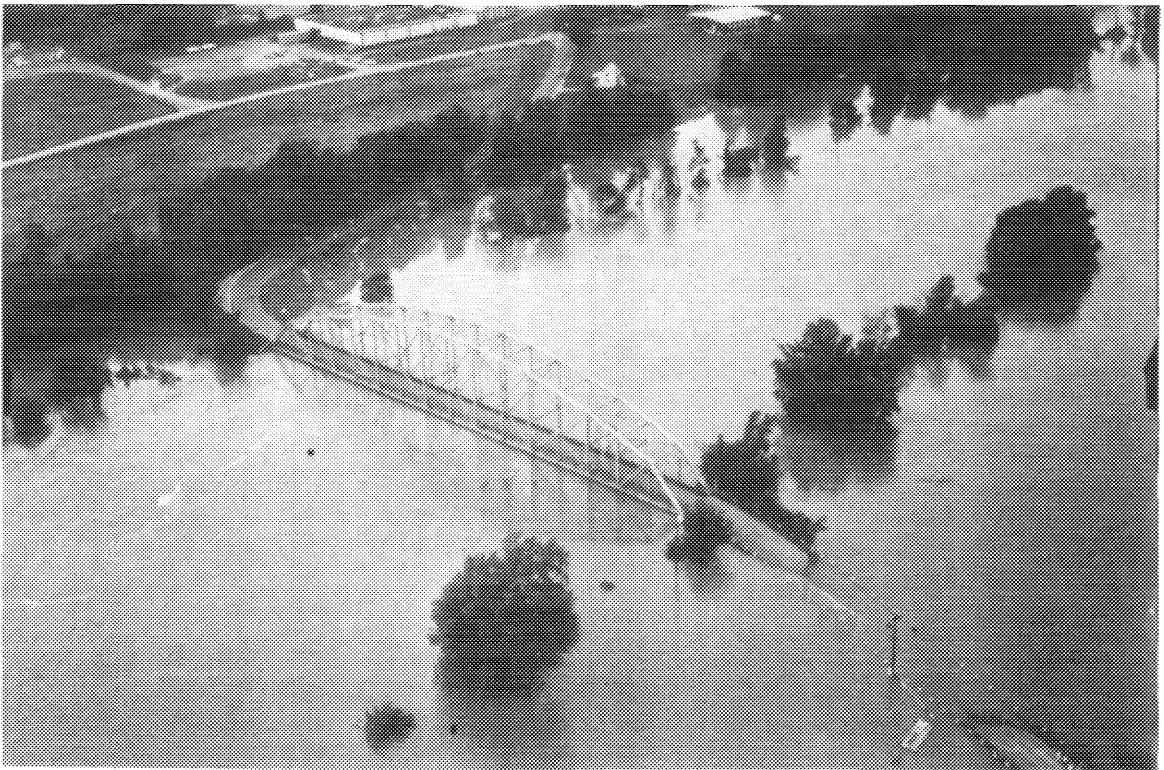
Bradford, Vt. - Rt. 25 bridge crossing the Connecticut River.

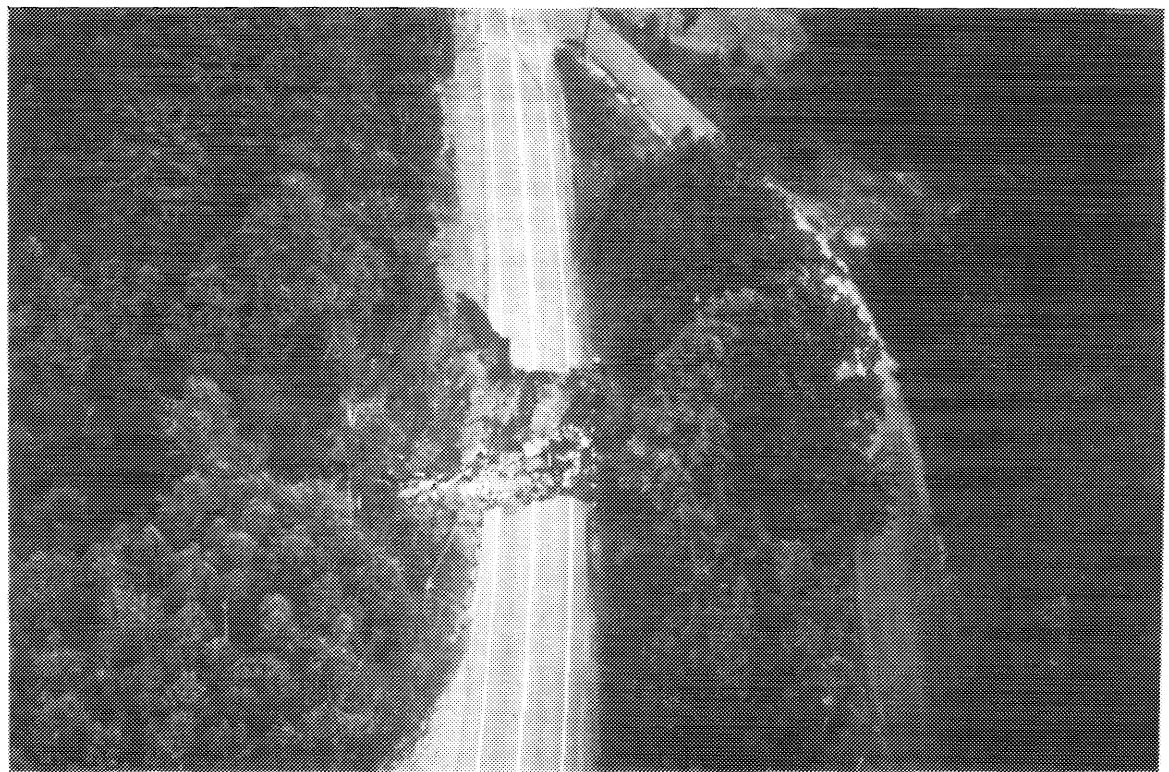
Highway near White River Junction, Vt.

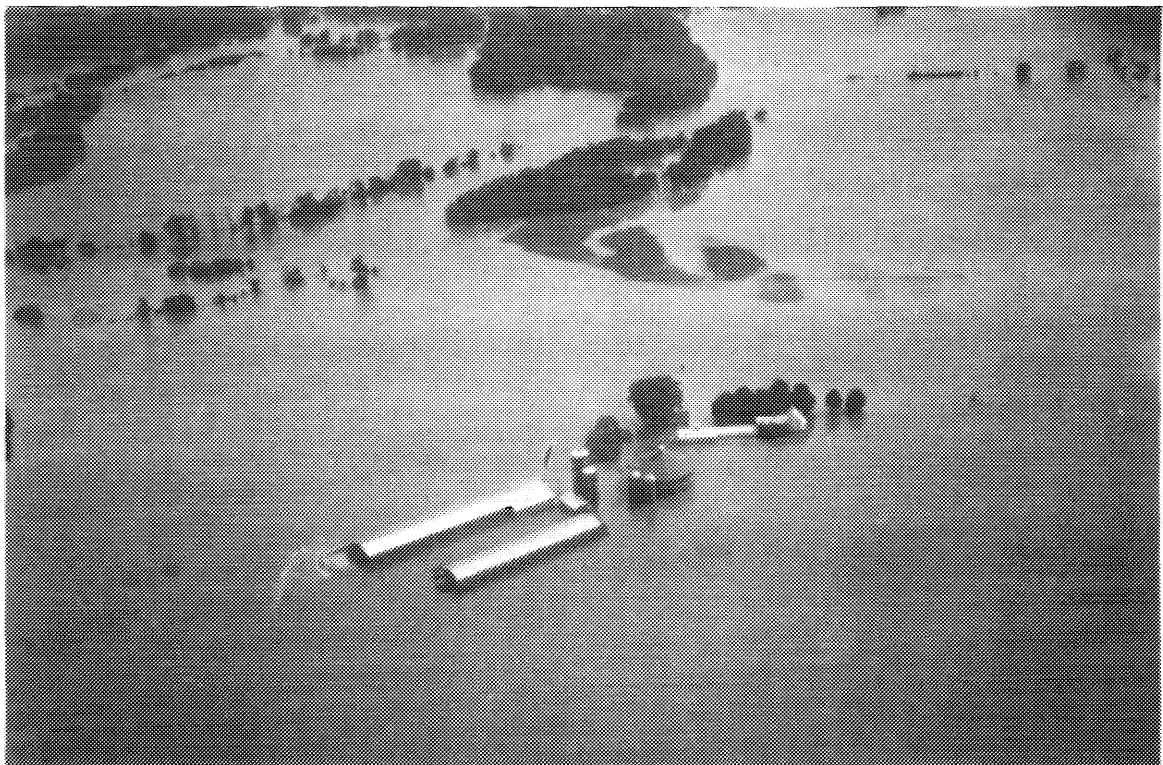
Wells River, Vt. - Dairy Farm

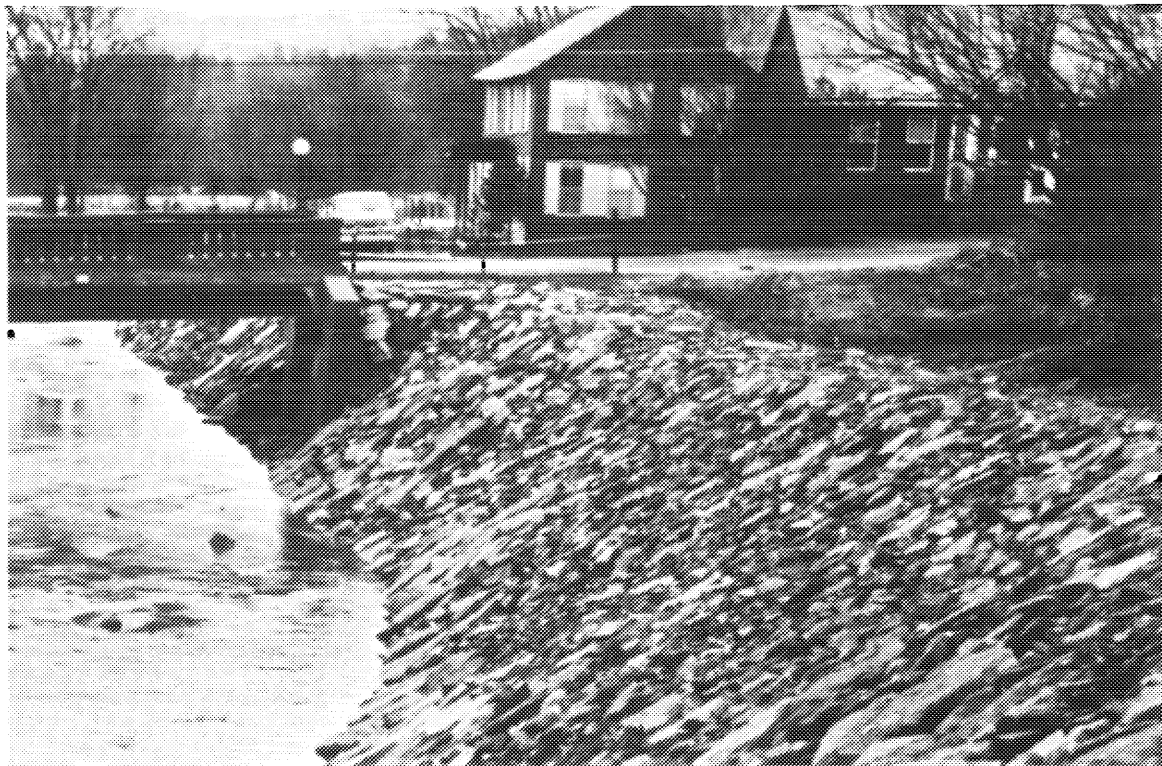
Weston, Vt. - Storm damage to highway bridge
and rehabilitation of bridge and West River channel slopes.

The July storm caused the river to overflow its banks at an old gristmill dam, undermine several buildings in the center of the small town, wash out a main and a few secondary roads, and severely damage both abutments on the highway bridge over the river.

In the rehabilitation of the project NED realigned the river channel, stabilized the river banks for 900' + through the town, and rebuilt the highway bridge abutments at a cost of \$140,250. In response to a special request from the Vermont Fish and Game Department, NED randomly placed rocks in the river channel downstream from the bridge to improve fish habitat conditions.

It is significant to note that the original project was designed for a fifteen (15) year recurring flood. The June-July 1973 flood was determined to be a thirty (30) year frequency flood. In the rehabilitation process, the highway bridge was found to be a serious channel constriction. The Vermont State Highway Department is presently considering replacing the old bridge with one which will have a hydraulic capacity equivalent to the portion of the channel upstream from the bridge. This project, however, is contingent upon the Town of Weston completing downstream channel improvements having similar hydraulic capacity.

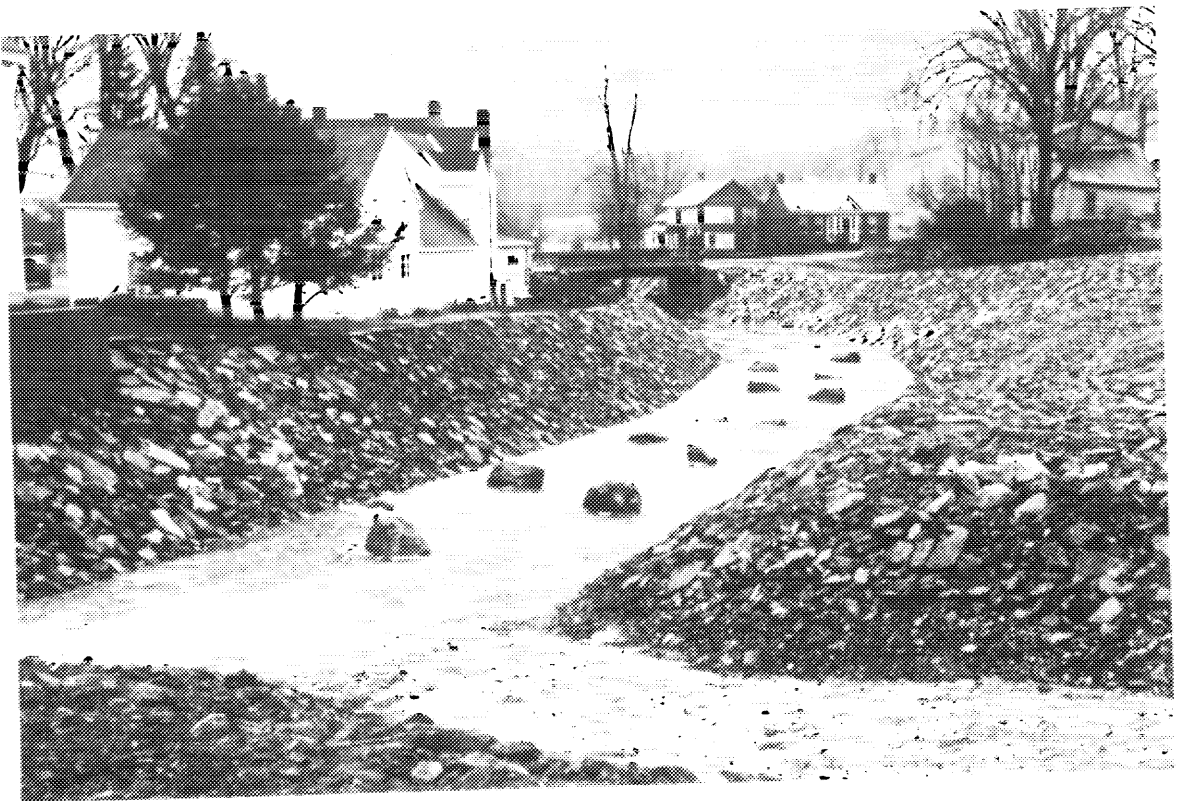
Weston, Vt. - Placed stone in West River channel
for improving fish habitat.

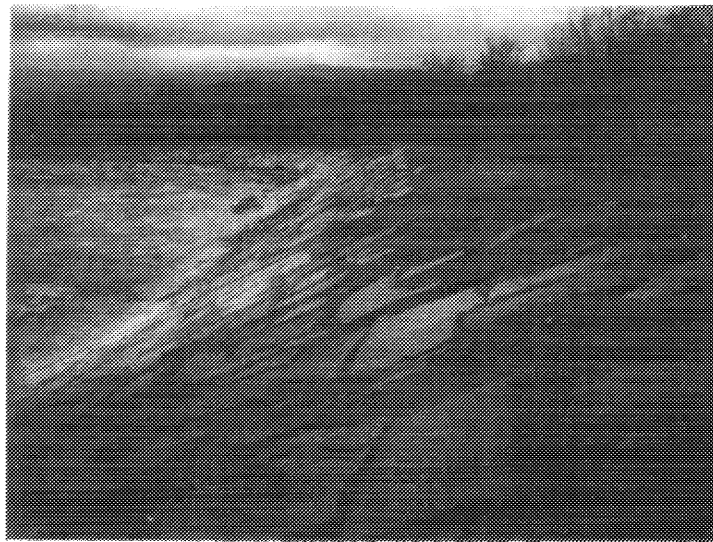
Lincoln, N.H. - Local Protection

Rehabilitation.
Looking south toward town of Lincoln.

NED solicited local contractor expertise to replace the bedding, re-establish the undermined toe, and realign the cover stone at a cost of \$20,500.
